Manhole Inspection Summary

Manhole # S3900_013MH

Insp Date: **4/4/07 12:19 PM**

Location Address: **2267 KIRK AVE**

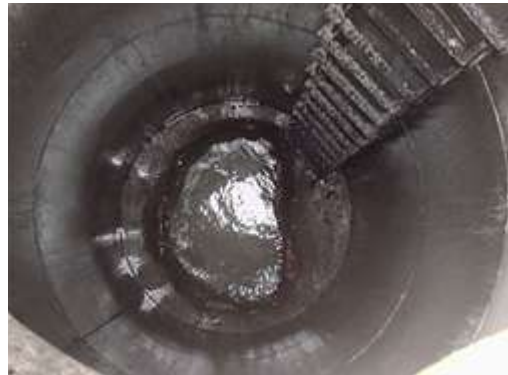
Top View

Corbel and Barrel infiltration. Evidence of surcharge - Bench debris.

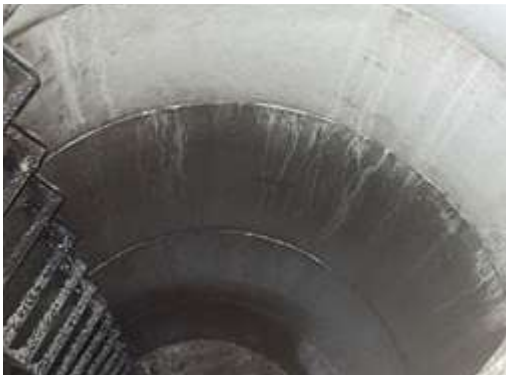
Defect

surcharge evidence on wall

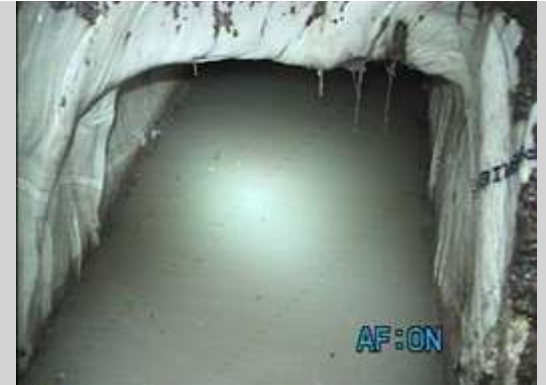
28 in. (w) x 42 in. (h) Horseshoe (inverted U) Gravity Sewer
Pipe Out @ 12 O'Clock

Invert Depth: **22.40** (ft.) Flow Characteristics: **Slow**

Infiltration: **None** Pipe Seal Cond: **Unknown**

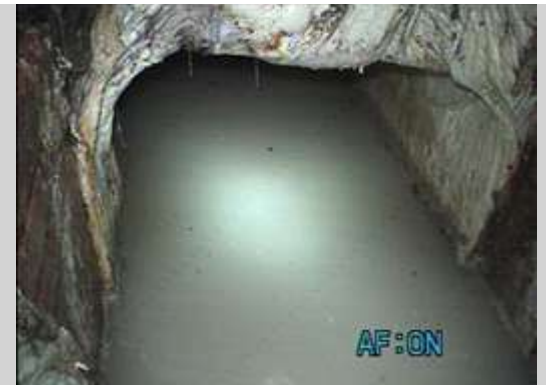
28 in. (w) x 42 in. (h) Horseshoe (inverted U) Gravity Sewer
Pipe In @ 5 O'Clock

Invert Depth: **22.25** (ft.) Flow Characteristics: **Slow**

Infiltration: **None** Pipe Seal Cond: **Unknown**
